Emails with Attachments #12 - #17

LIMITED SITE ASSESSMENT

**THE POP SHOPPE – HICKSWOOD RD
2400 EASTCHESTER DRIVE
HIGH POINT, GUILFORD COUNTY, NC
GROUNDWATER INCIDENT: 45311
FACILITY ID: 00-0-0000035614**

Reference: Limited Site Assessment
The Pop Shoppe – Hickwood Rd
2400 Eastchester Drive
High Point, Guilford County, NC
Groundwater Incident # 45311
Facility ID # 00-0-0000035614

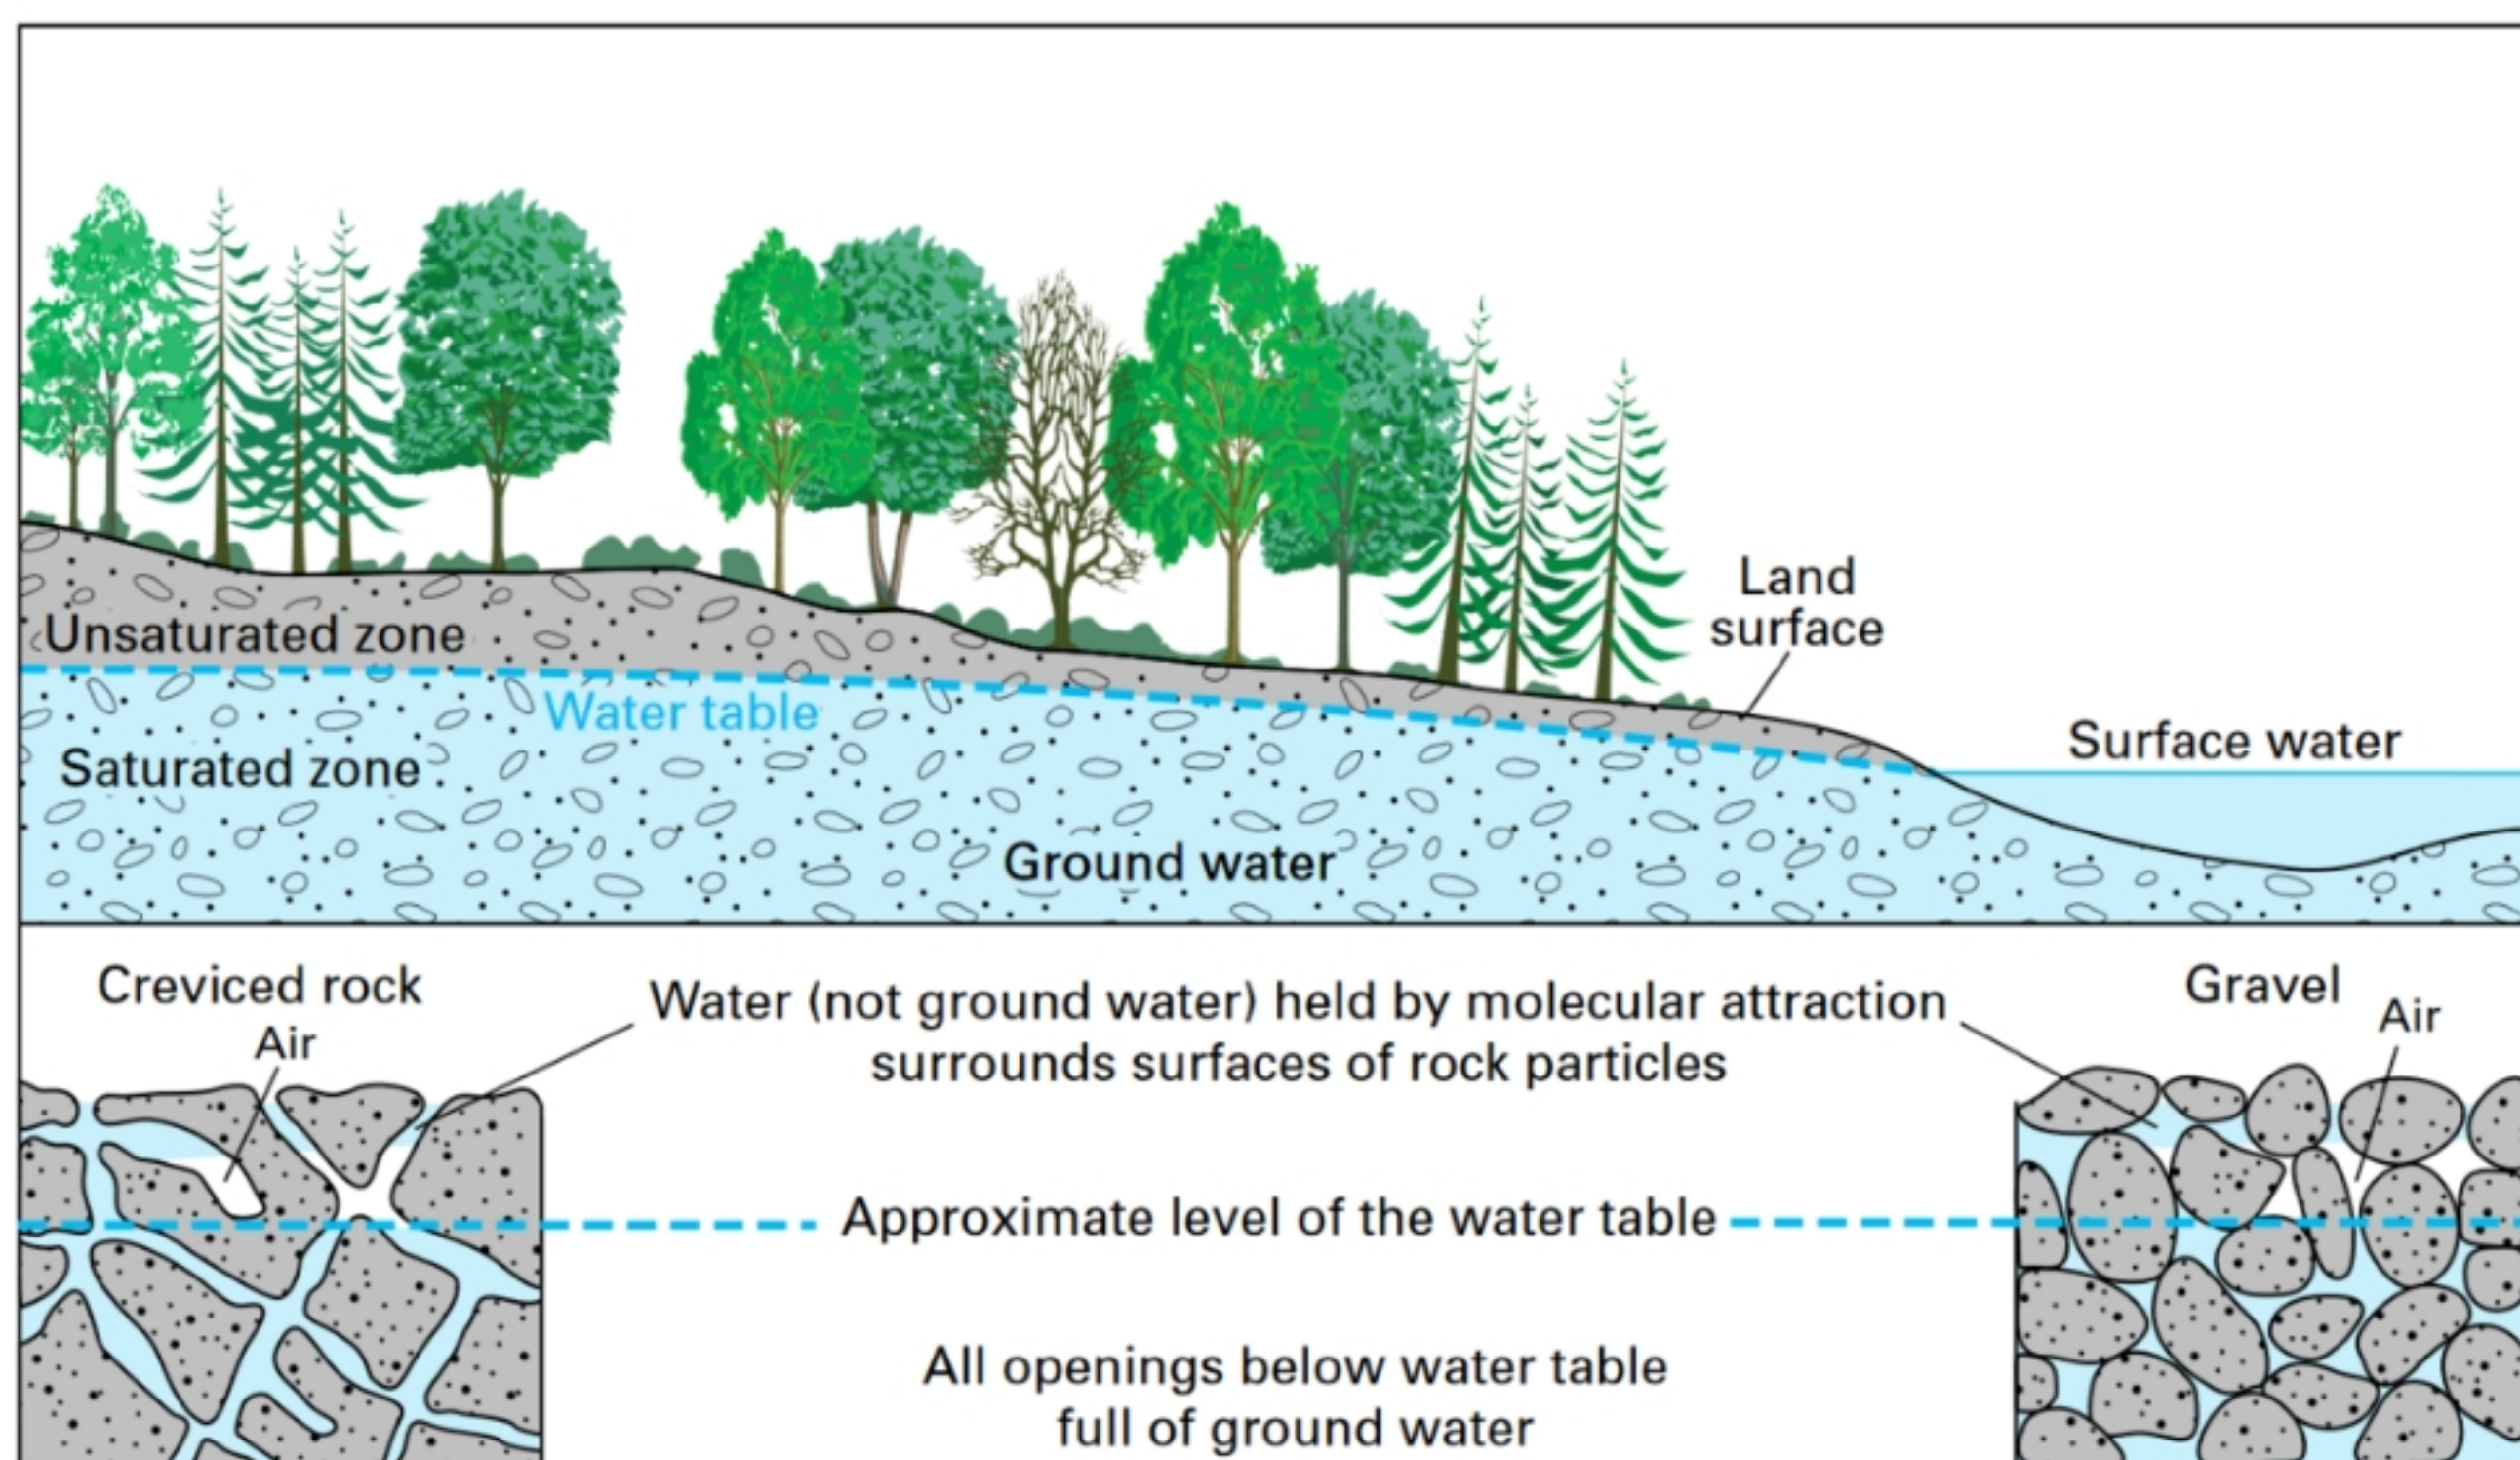
Groundwater is the saturated zone of soil/rock below the land surface

How ground water occurs in rocks.
(Public domain.)
